Technical Decontamination Support Systems Assessment Report

March 2007

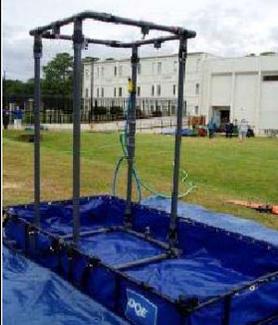
<p>DQE Standard Decon Shower (#HMK1101) <i>Photo courtesy of CDP</i></p>	<p>DQE</p>

The DQE decontamination shower received the highest evaluator capability, usability, affordability, maintainability, and composite scores. Evaluators reported that the six adjustable DQE shower heads provided a consistent, encompassing spray. The spray completely covered the evaluators from multiple directions during the assessment rotations, and the accessory spray nozzle allowed the evaluators to rinse the bottom of boots and other difficult-to-reach areas. In addition to the excellent spray coverage, the evaluators pointed out that the shower was very water efficient. Evaluators stated that the polyvinyl chloride (PVC) pipe frame was rugged and well-constructed, and the color-coded quick-connect pipe connectors made setup and takedown quick and easy.
